# Lessons learned from Milagro

## Outrigger Detectors

John A.J. Matthews

University of New Mexico

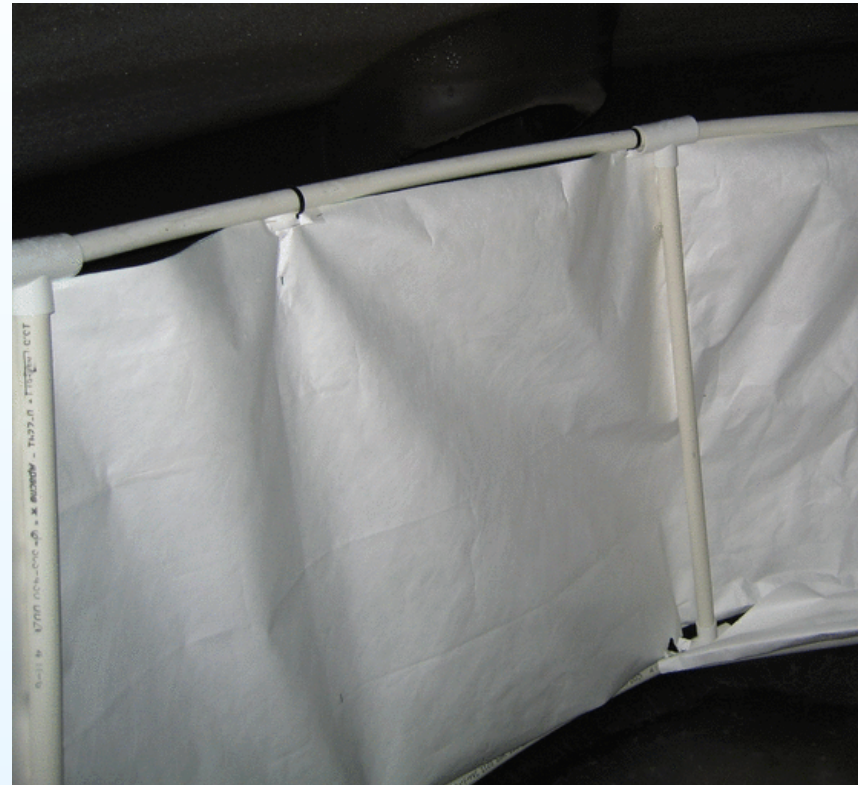
## View of one tank ... **cylindrical side detail**

- View into tank being disassembled for shipment ...
- Tank had be running for  $\sim 2$  years
- **Every component looked as *new* as if it had just been installed!**

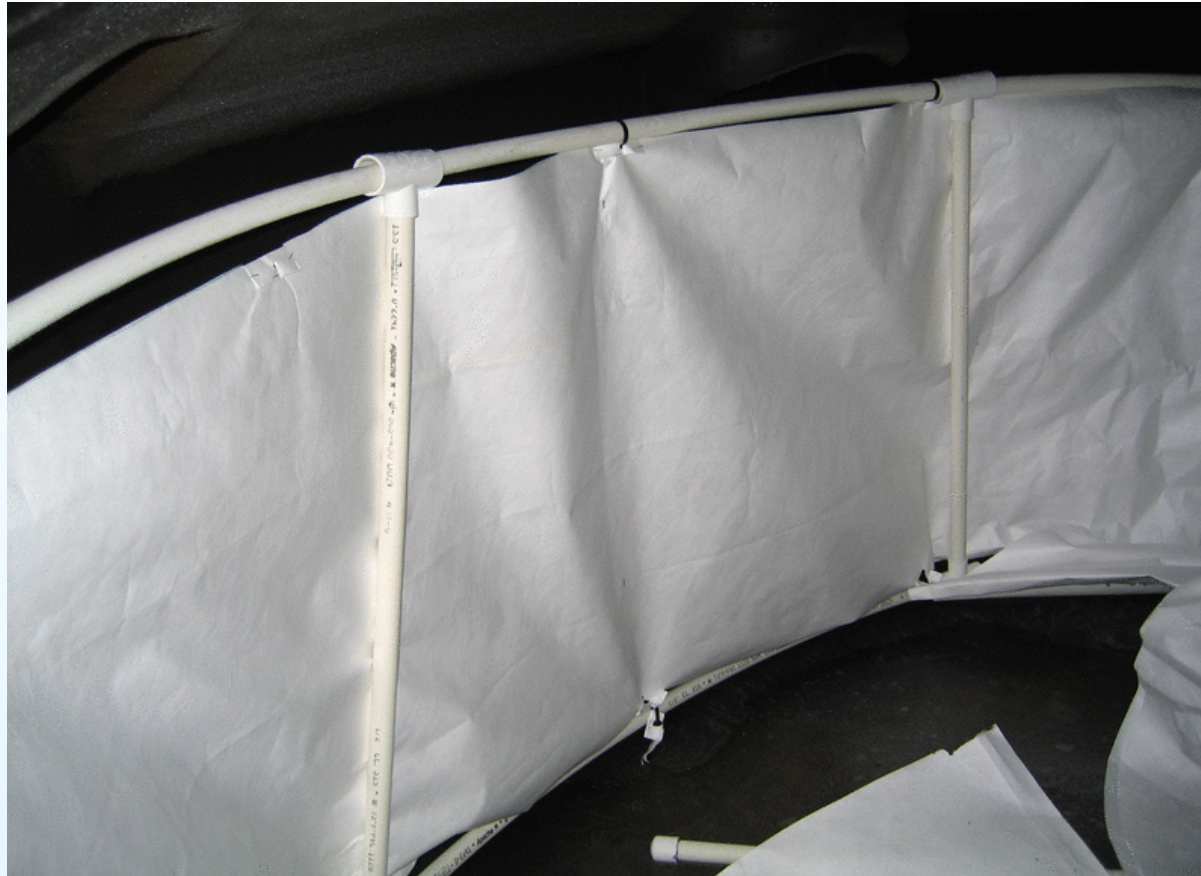
## Another view of one tank ... **cylindrical side detail**

- View into tank being disassembled for shipment ...
- Wrinkling of the TYVEK on the sides ... representative or not?
- Top and bottom pieces of TYVEK and bottom x-pieces had been removed!

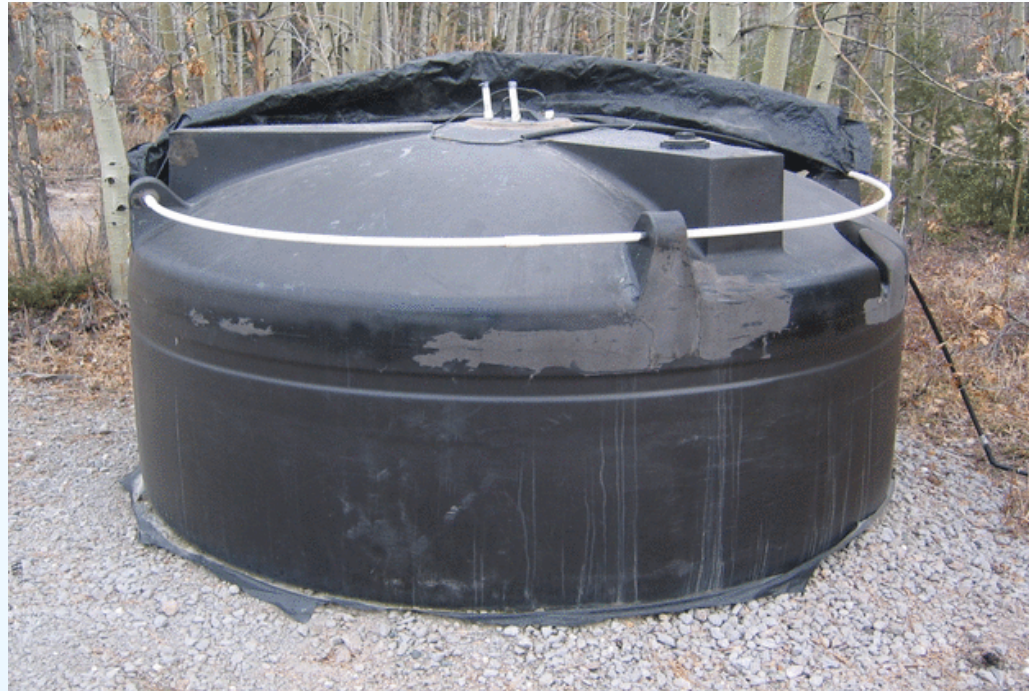
- *Bobcat* used to clear/flatten the site.
- Often (but not always) road aggregate is added ... possibly for better tank-ground contact (**what about using sand?**)
- **And** most tanks have a plastic sheet under the tank.

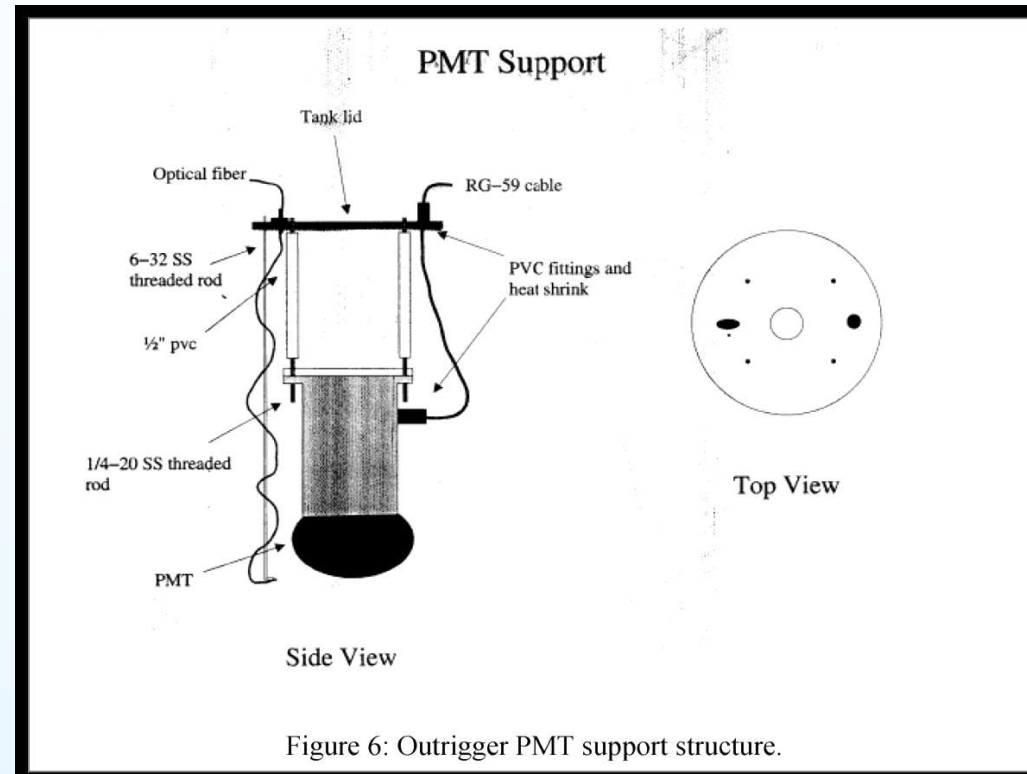
- Water covers the PMT ... but not the entire PMT housing!
- Thus PMT base (electronics) subjected to extreme daily temperature fluctuations
- Some unhappiness with cable feed-through into PMT housing ...
- Ice formation has not damaged any PMTs (or effected the response significantly) but it has damaged the optical (calibration) fibers!

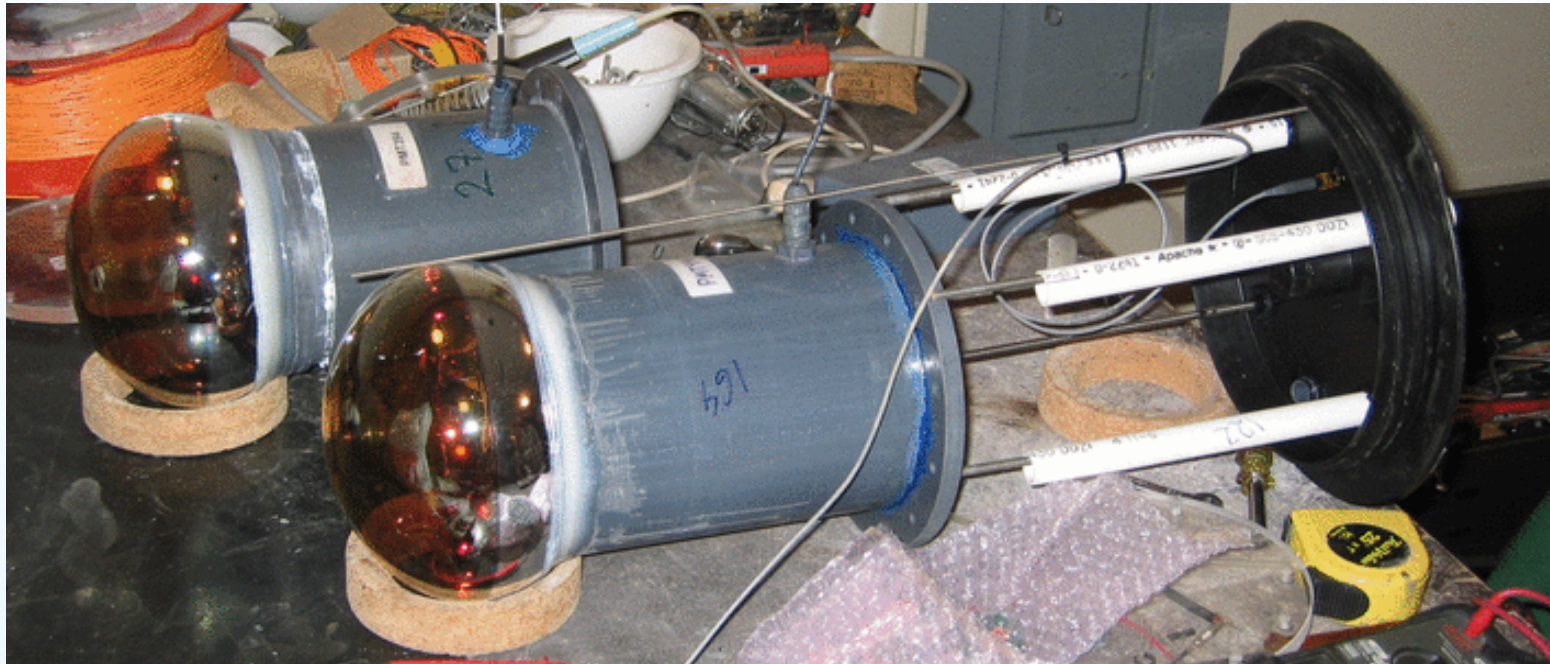
- PMT to PMT-housing sealed with RTV
- Water level visible a few inches above the RTV (by the 4 in the handwritten 164)
- Threaded rods position and support the *Milagro pond PMT housing* in the *outrigger tanks*!

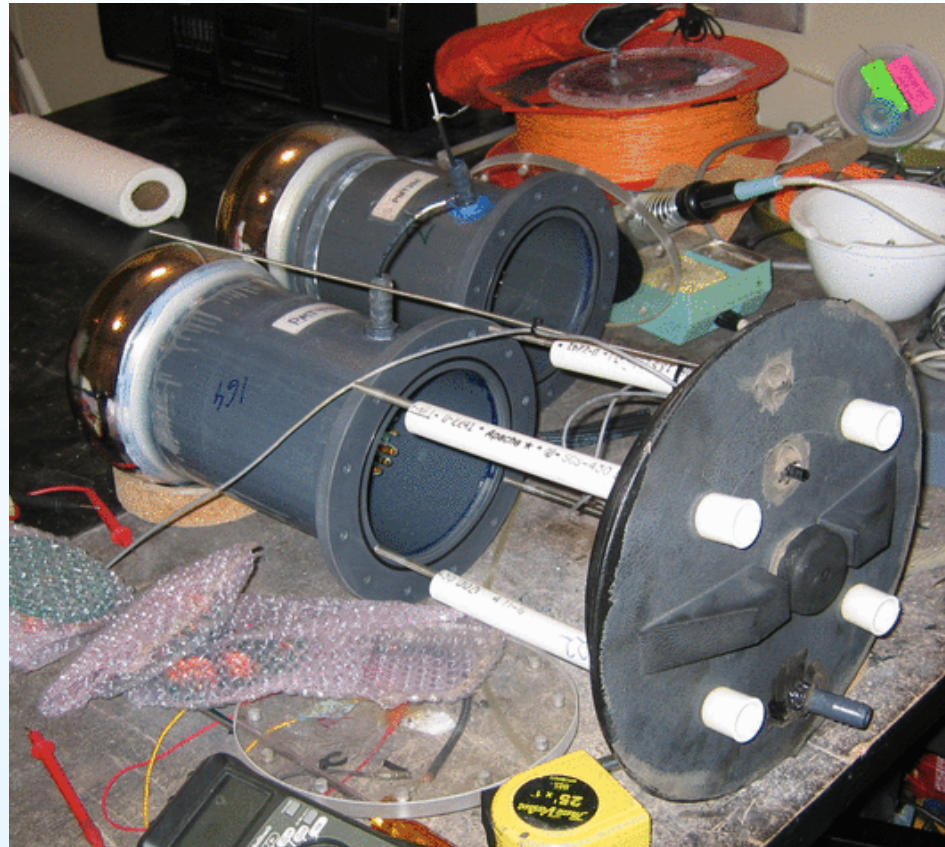
- Threaded rods connect to 10" tank access-port cover.
- Light leaks patched with black roof tar!

- Without a separate light-tight water enclosure, the (black) tanks needed to be opaque. One iteration with the vendor was needed to get sufficient black pigment for light-tightness.
- **But even *accepted* tanks randomly had light leaks!** These were patched with roofing tar ... but the location of the light leak was difficult to find and to repair in a permanent way. Some of the light leaks were related to the cable/fiber feed-throughs. [No comments on the effect of temperature variations and/or weather on appearance of light leaks.]
- By comparison almost no tank water-leaks!
- Tank internal (air) temperature variations were large, especially in the summer, and resulted in PMT gain variations that were significantly greater than the same (fully submerged) PMTs in the Milagro *pond*.
