Temperature Measurements in a Milagro Outrigger Detector

John A.J. Matthews and Bill Miller

University of New Mexico

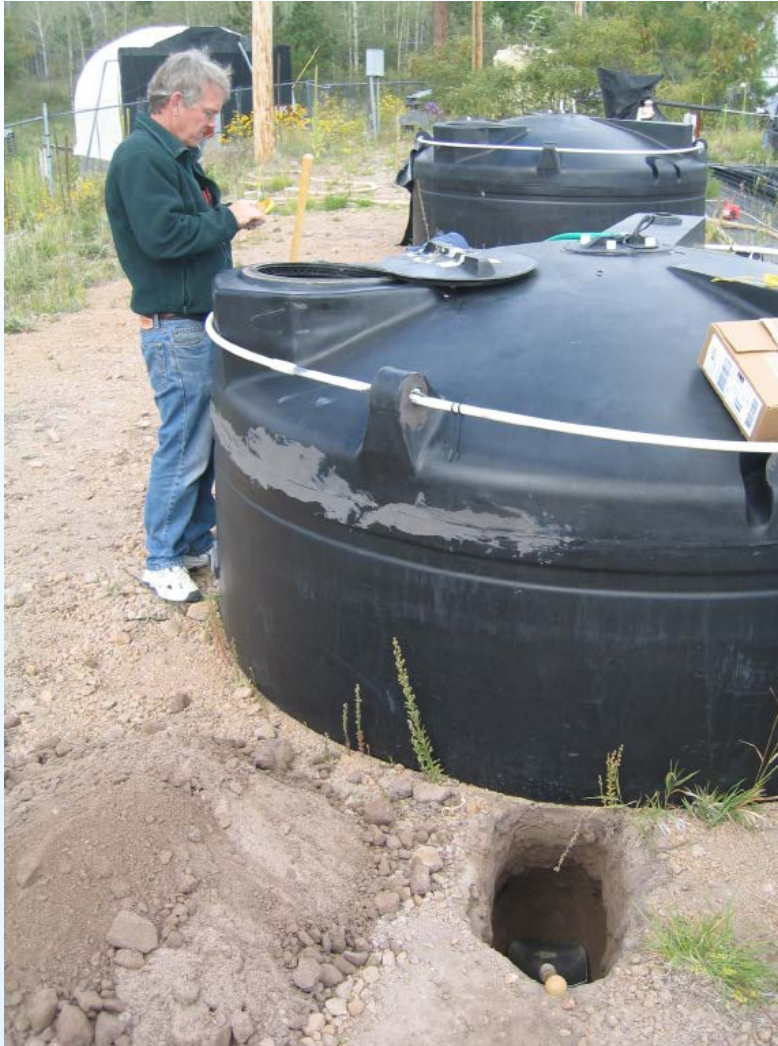
Outrigger detector ... Instrumented Sept. 2006

- Top fill port: 4 temperature sensors
- Hole *under* detector
~ 22"-deep with 2 temperature sensors:
one ~18"-(in) from tank edge [Ch 1] and one
~12"-(in) from tank edge [Ch 2]

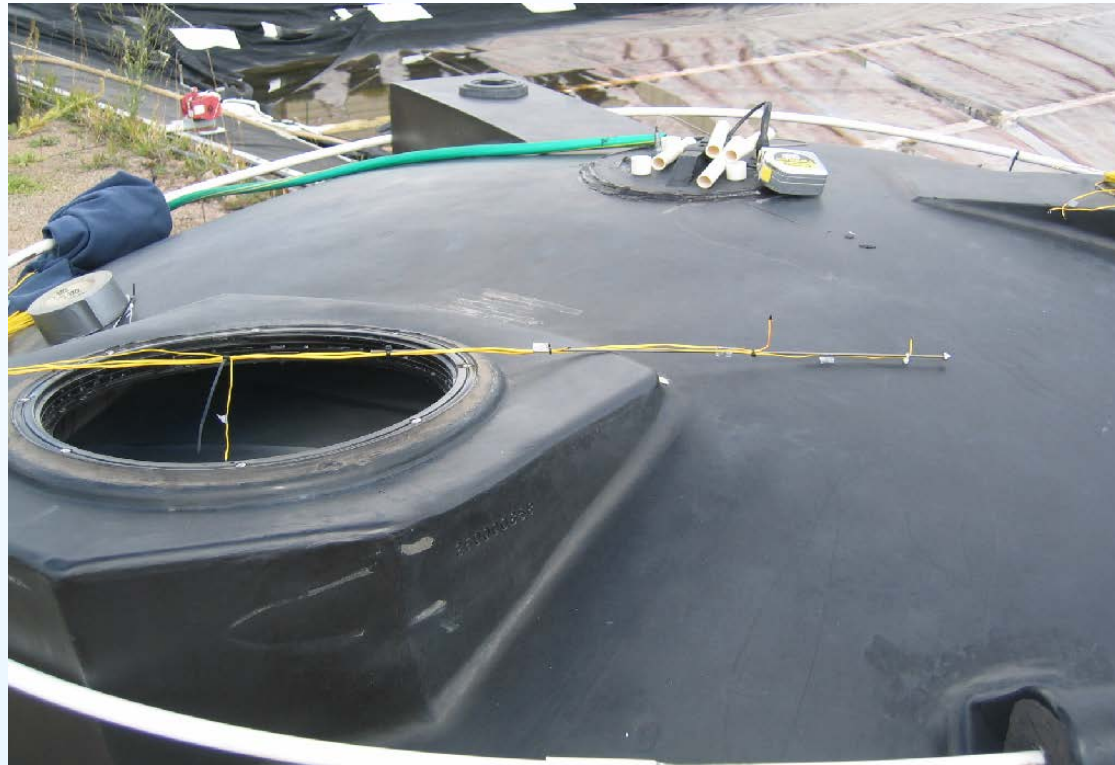
In-tank ... string of 4 sensors

Thermocouple string:

- $\sim 13''$ in from the edge of the tank
- depths (below the surface of the water) of $<1''$ (*i.e.* "at the surface") [Ch 4], $14''$ below the surface [Ch 5], $22''$ below the surface [Ch 6] and $28.5''$ below the surface (*i.e.* about $1.5''$ above the bottom) [Ch 7]

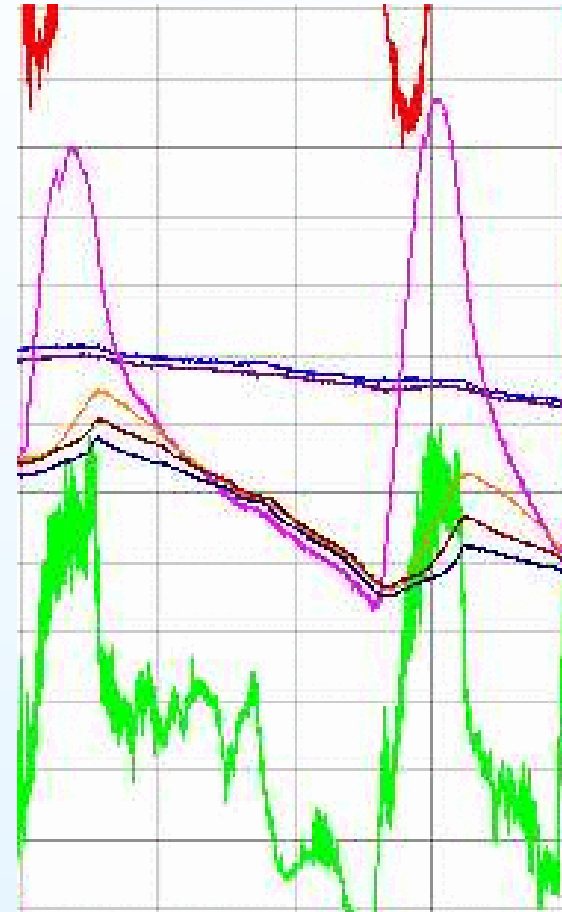
Tank temperature ... September 2006 details

- [left plot] tank T-sensors show T-gradient: coolest (bottom=black) to warmest (top=violet) ... *large daily temperature variations* ... **not a good thing!**
- [right plot] but NO T-gradient on cloudy days!

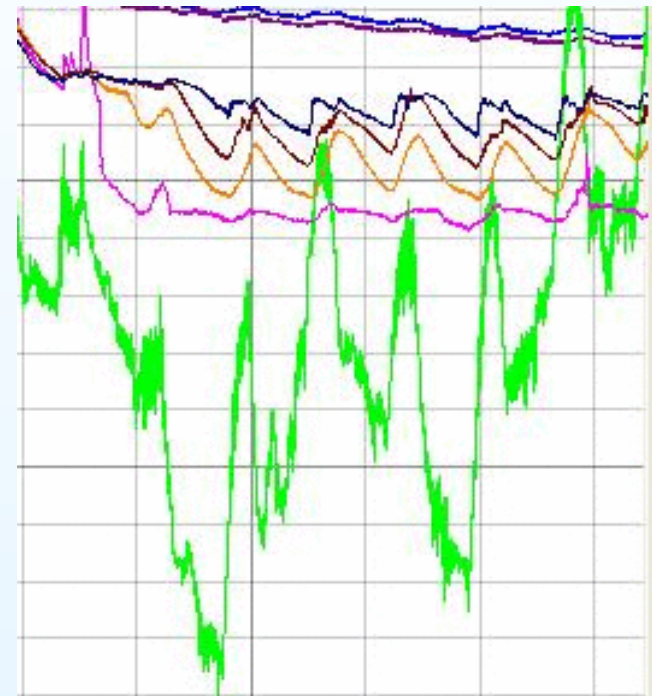
Tank temperature ... November 2006 details

- [left plot] tank T-sensors show **inverted** T-gradient: coolest (top) to warmest (bottom) ... with top probably freezing at night and thawing during the day ... **not a good thing!**
- [right plot] now the top (**violet**) stays frozen day and night!

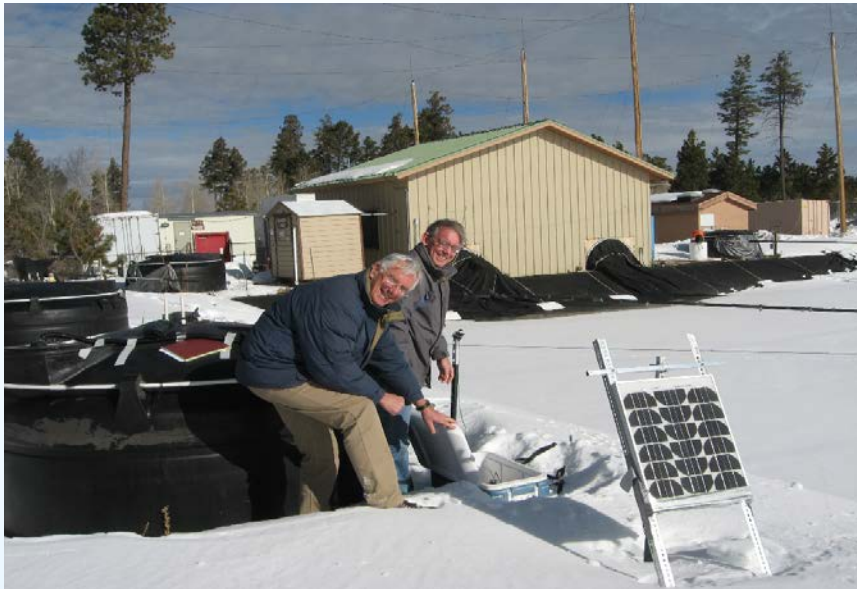
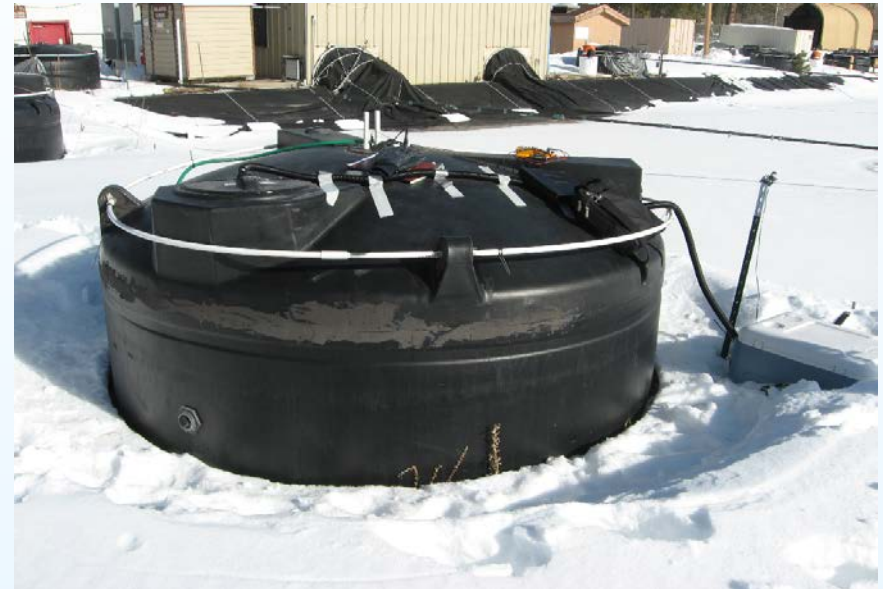
Then endless snows ... until late Jan 2007

- Milagro experiences significant snow cover during the coldest months.
- Tanks in full sun have least snow (cover).
- Tanks in the shade (not shown) can be totally covered.

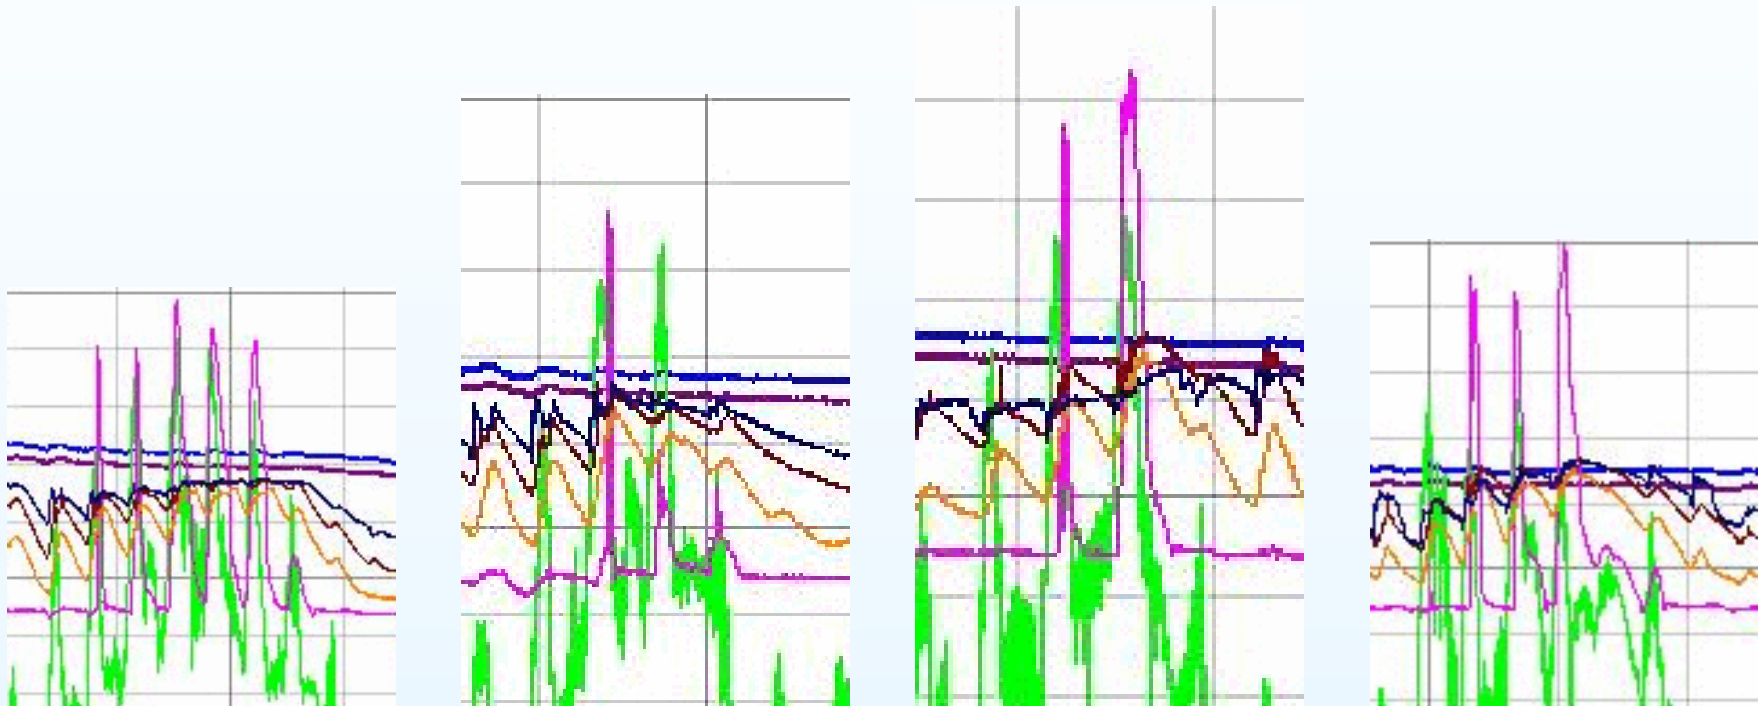
Tank temperature ... January 2007 details

- **Note:** likely temperature offset of $\sim 1^\circ$ for all sensors
- Many (more) examples of tank surface (violet) night-time freezing followed by day-time warming
- Other depths in the tank (orange, brown and black) above freezing

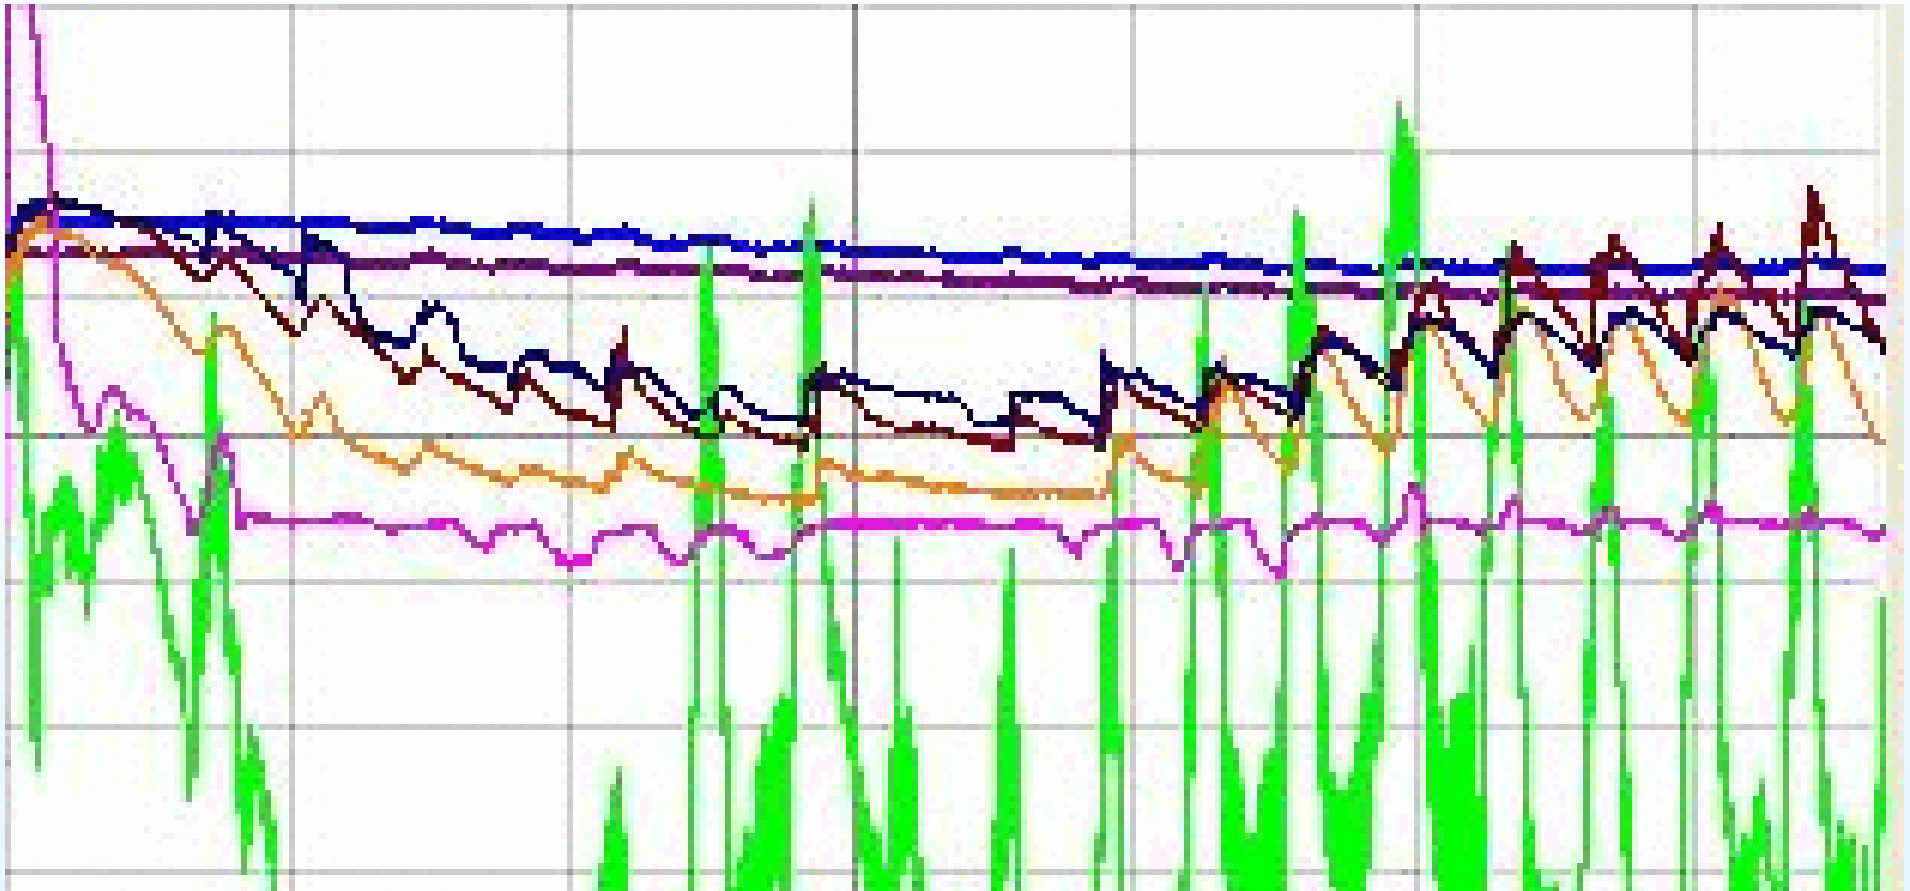
Tank temperature ... January 2007 details

- Only **one** period of sustained freezing of the tank surface (**violet**)
- Middle of the tank (**orange**) close to 0° but probably above freezing
- **Ground temperatures remain above freezing** ($\sim 3^{\circ}\text{C}$)
