Milagro Tank Temperature Study: w/ and w/o Tank Insulation

Tank Temperature Study for Northern Auger

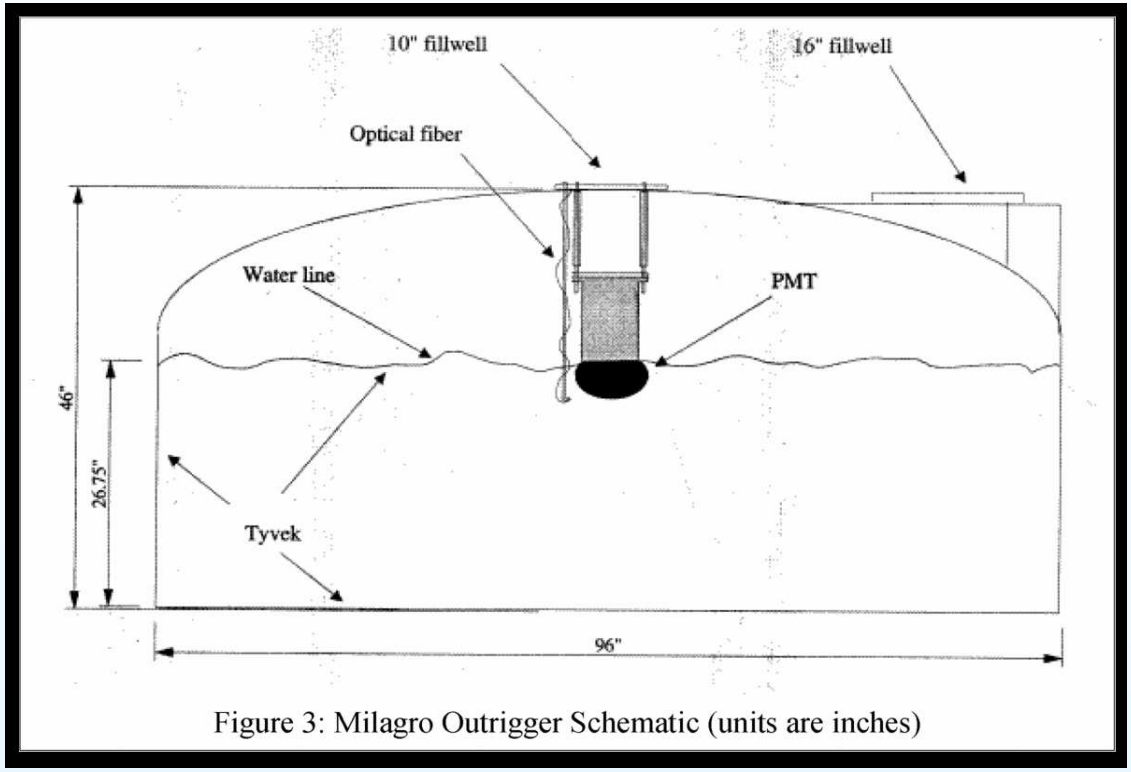
Figure 3: Milagro Outrigger Schematic (units are inches)

- **One** central PMT, enclosure $\sim$ 1/2-immersed, **only electronics: PMT-***base*
- Water depth *typically* $\sim$30-inches (*i.e.* deeper than drawn)
- Smaller water volume and colder winter temperatures (than Auger South)
- In winter often "several inches of ice on water top surface/sides

... but never close to freezing solid!"

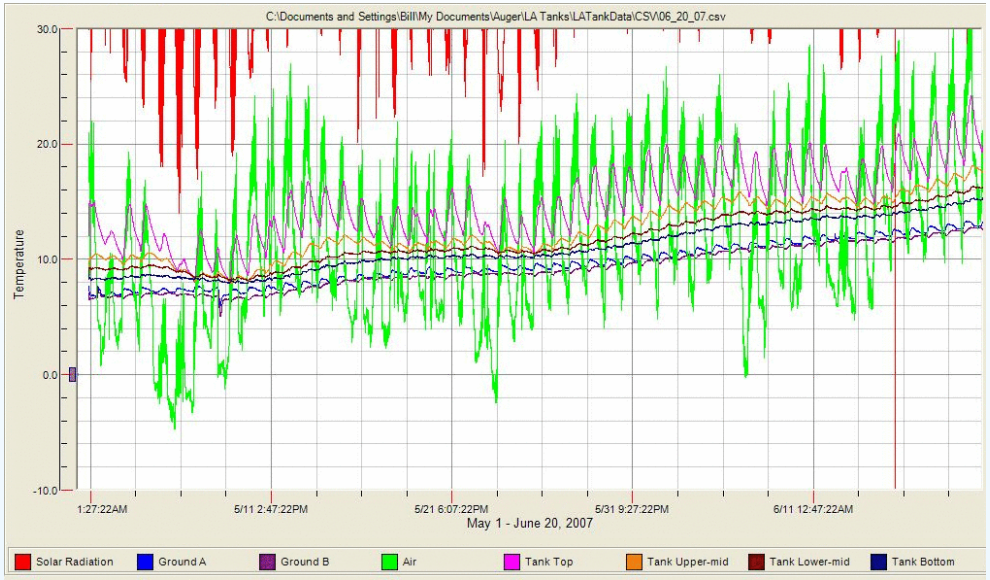
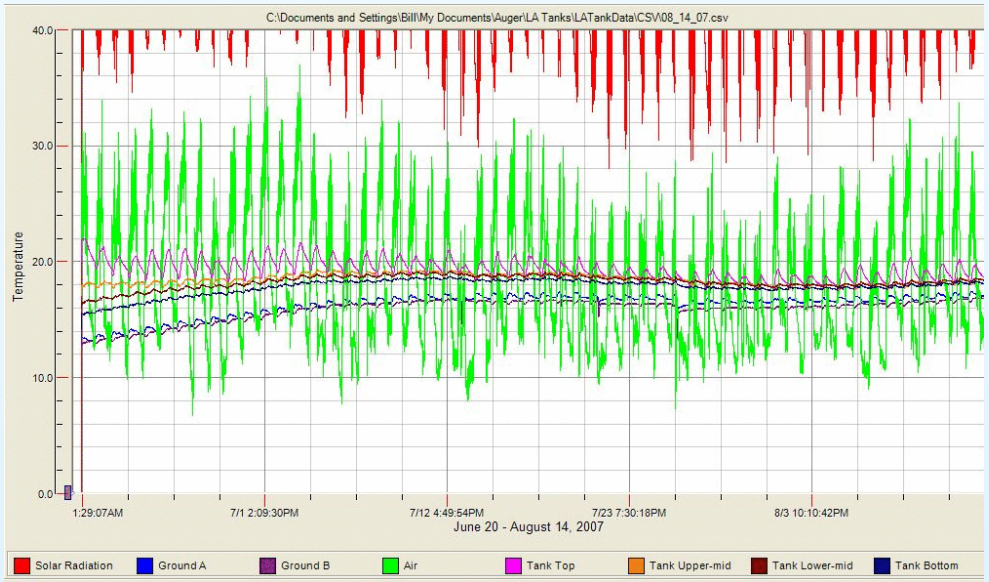
1/2 and full covering with R13 insulation

- **Top:** tank 1/2-covered with insulation
  - significant daily internal temperature variations
- **Bottom:** tank fully-covered with insulation
  - **only sensor at water/air interface shows daily temperature variations**
  - temperature sensors in the tank take ~ 10 days to come to new equilibrium ... *i.e.* **the tank is now in slow motion!**
  - tank and ground temperatures now show a strong correlation!

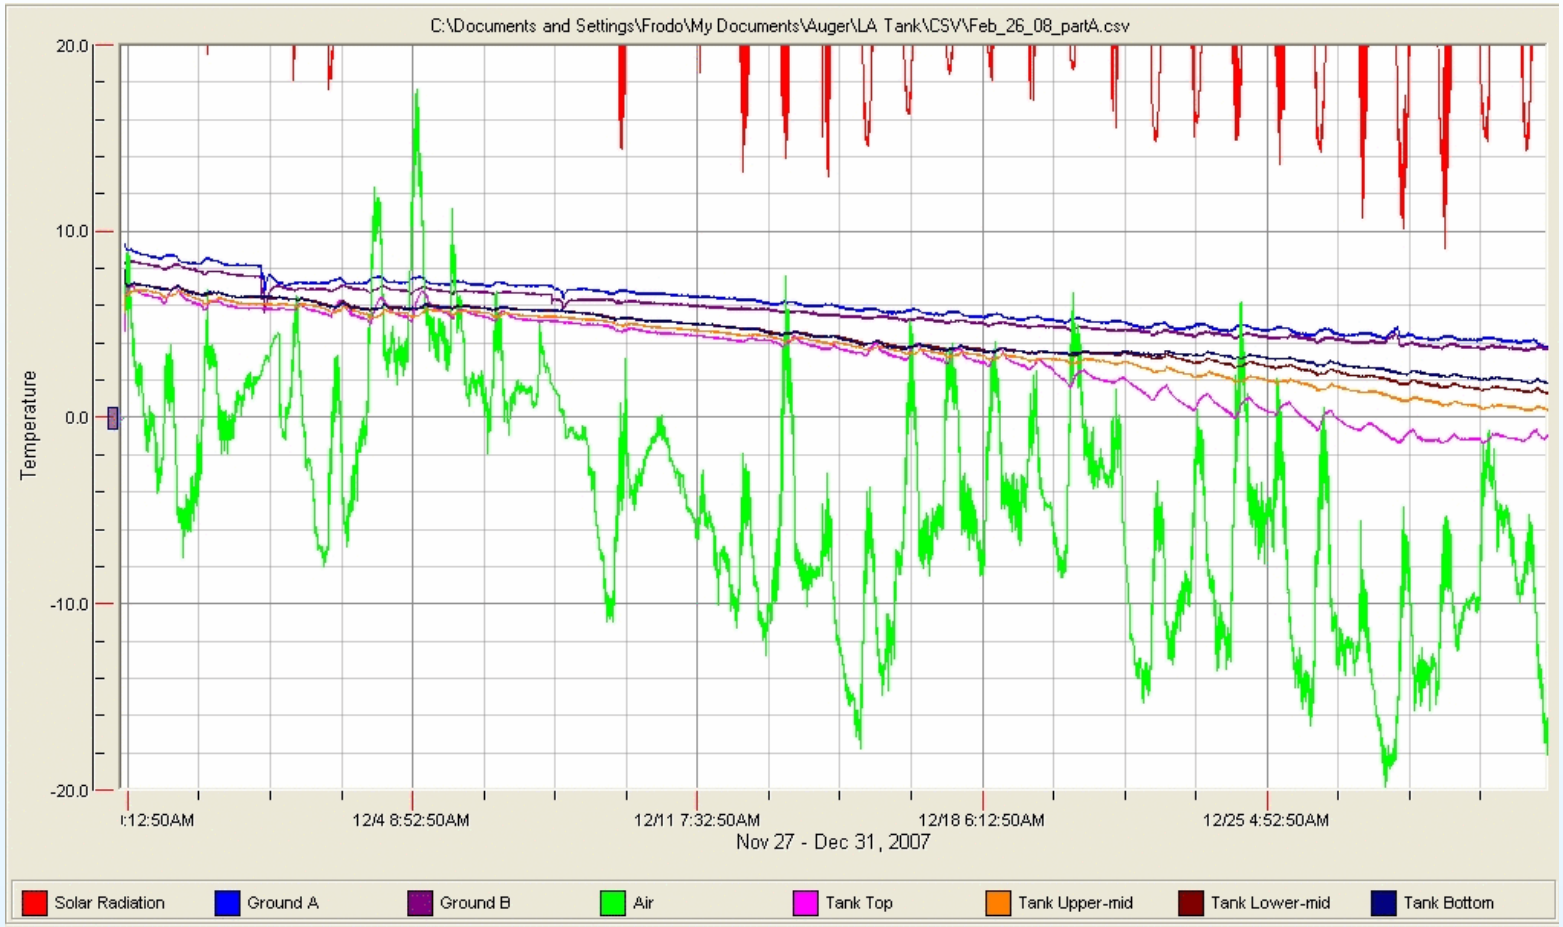
First surface freezing: **late December 2007**

- Ignoring winter to winter differences, the insulation has delayed the time to the first tank freezing (*i.e.* previous year first freezing was in mid-November 2006)

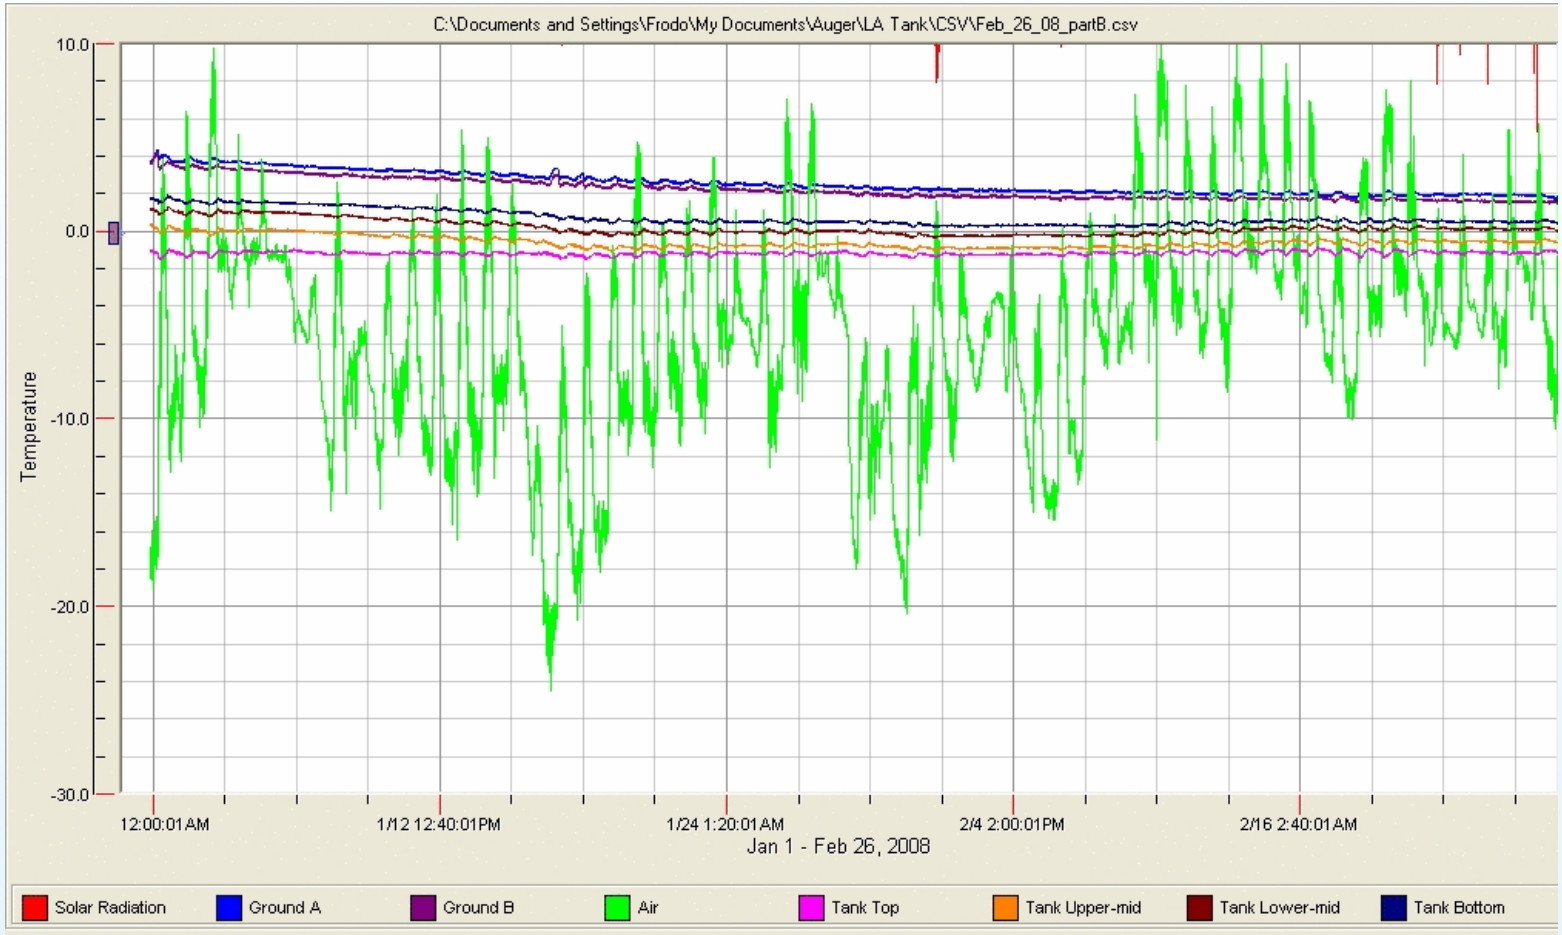
Winter data access: **late February 2008 (II)**

- The reduction of solar daily temperature variations with R13 insulation makes it more difficult to monitor the amount of tank freezing ... (or does it?)

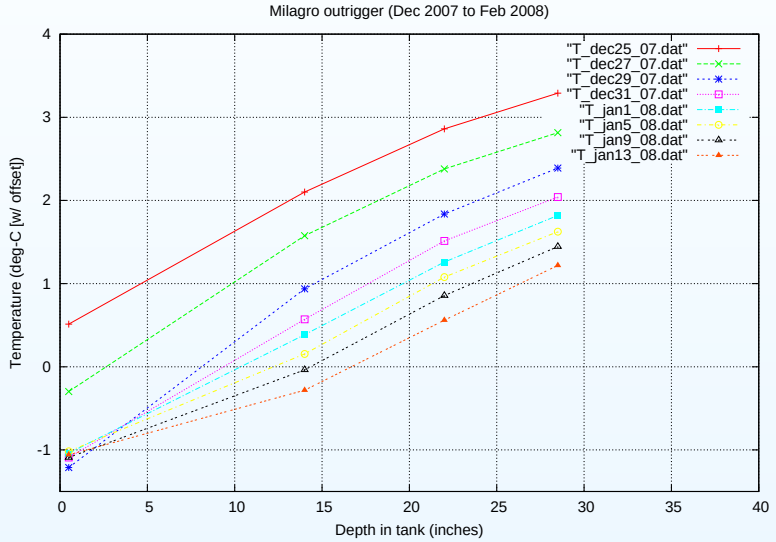
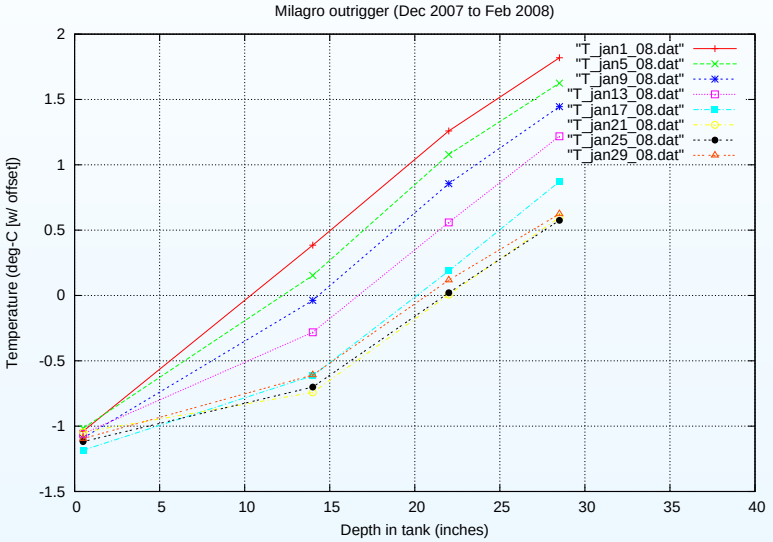
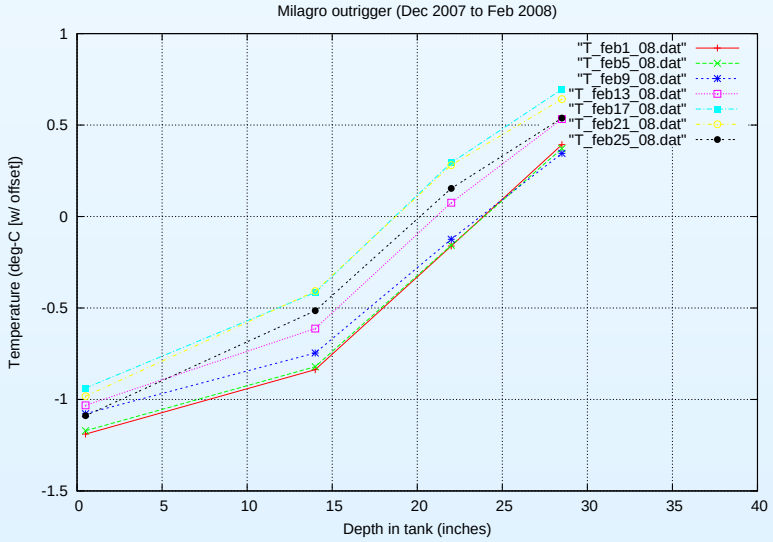
Winter data access: **late February 2008 (III)**

- Once the tank has a layer of ice, the three bottom sensor *temperatures* are approximately linear with *depth in the tank*
- This is consistent with heat transfer by conduction with stable (ice) and (ground) boundaries.

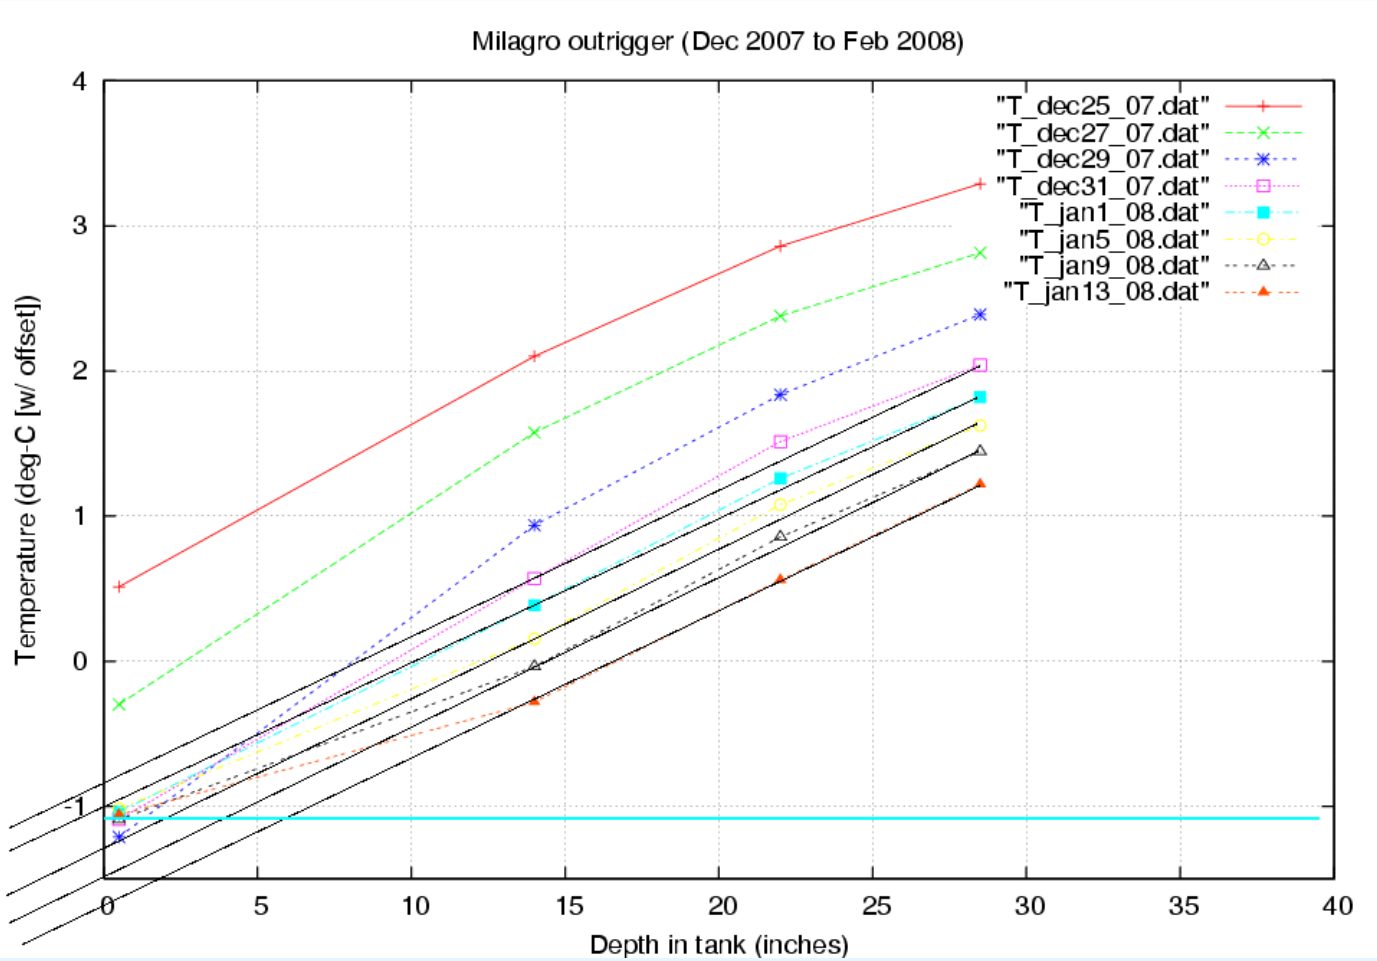
Winter data access: **late February 2008 (IVa)**

- We extrapolate the *linear* **T** *VS* **depth** to the ($\sim -1^\circ$ offset) temperature of the ice.
- This suggests that a **several inch thick layer of ice** forms on in the tank.

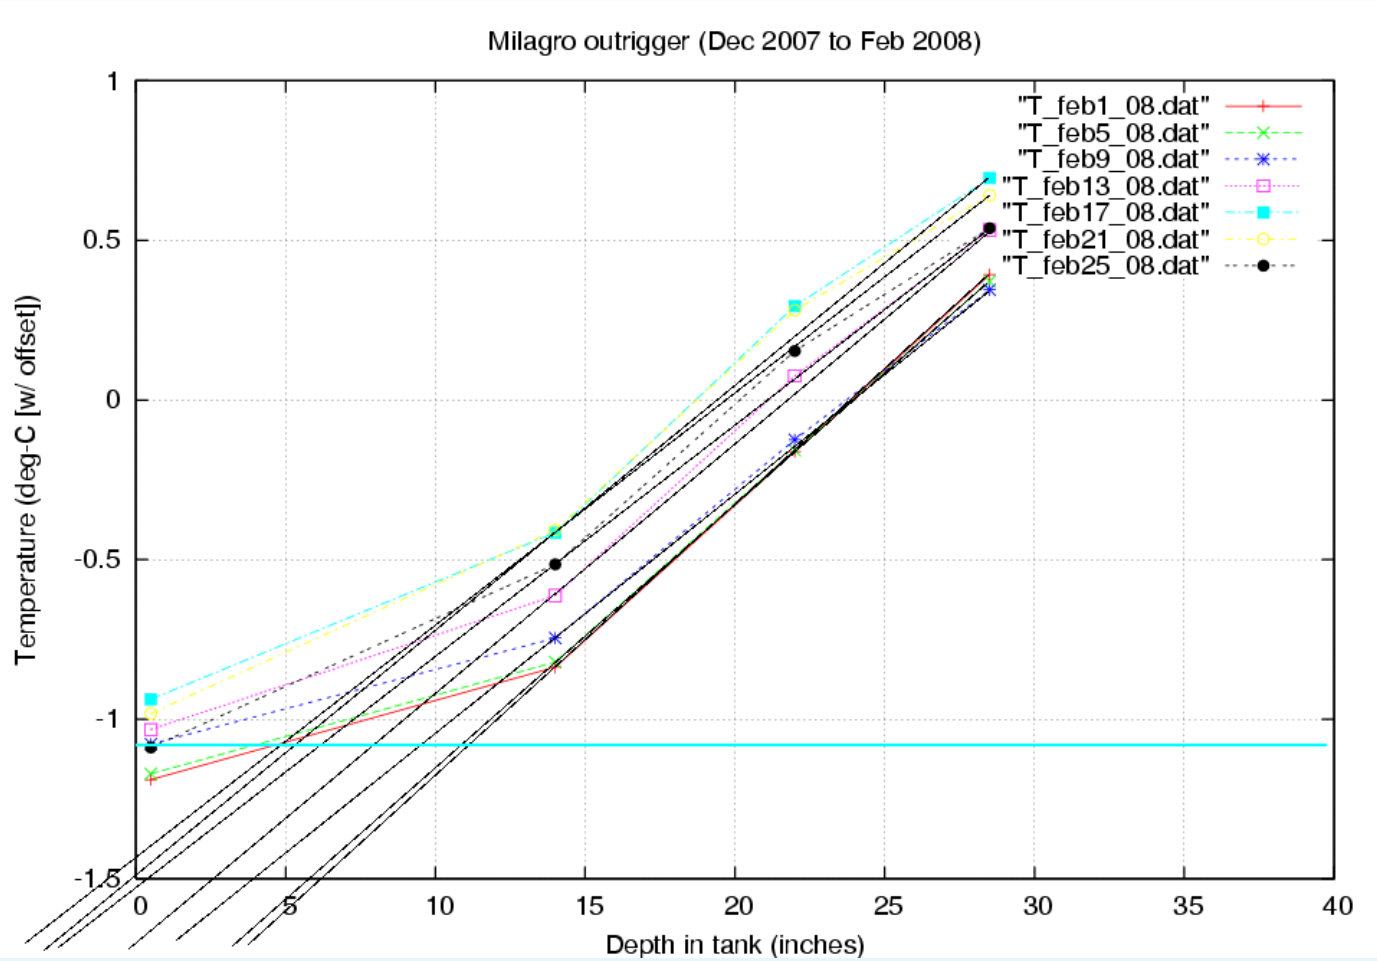
Winter data access: **late February 2008 (IVb)**

- In this model, the ice was thickest (~ 11") February $1 \sim 5$ 2008
- How clear is this ice **and** how does this effect the performance of the tank?

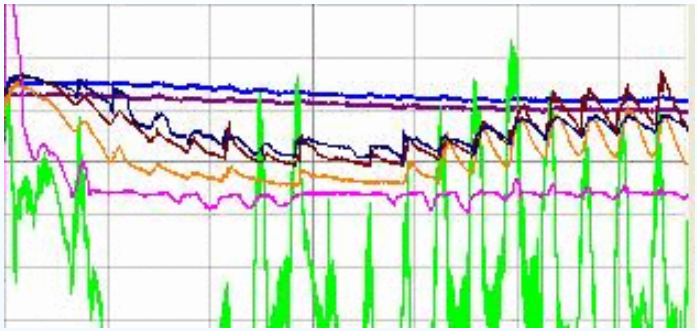
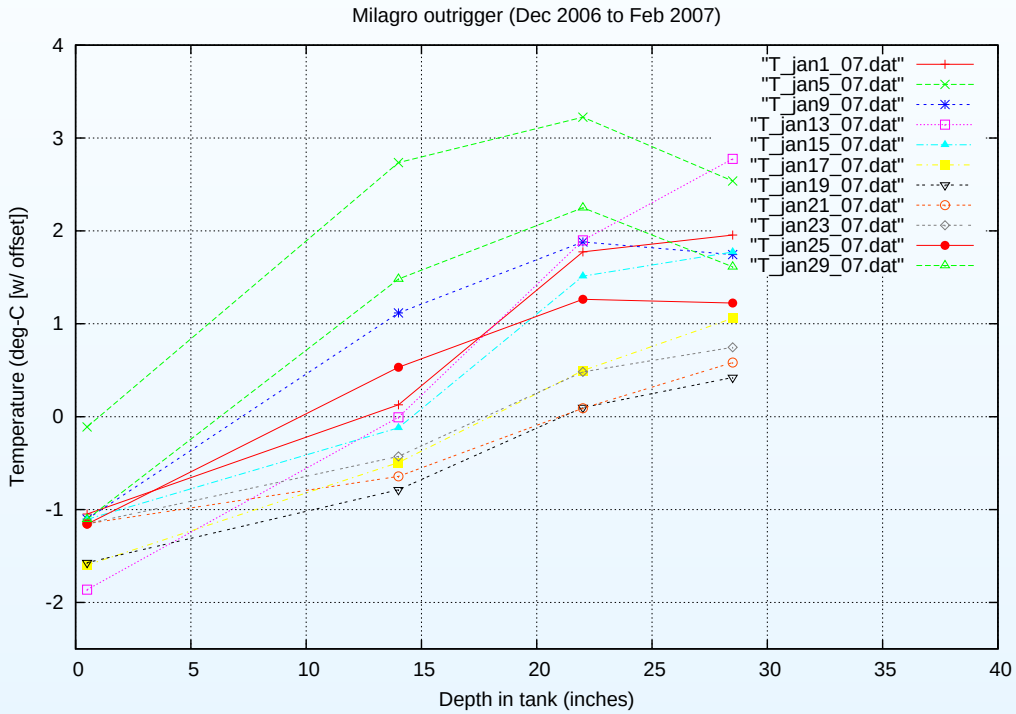
Coldest period previous winter: **late January 2007**

- Only **one** period of sustained freezing of the tank surface (**violet**)
- Middle of the tank (**orange**) close to 0° but probably above freezing
- Linear temperature model (again) suggests $\lesssim 11$" of ice on the tank
- **Ground temperatures remain above freezing** ($\sim 3^\circ$C)

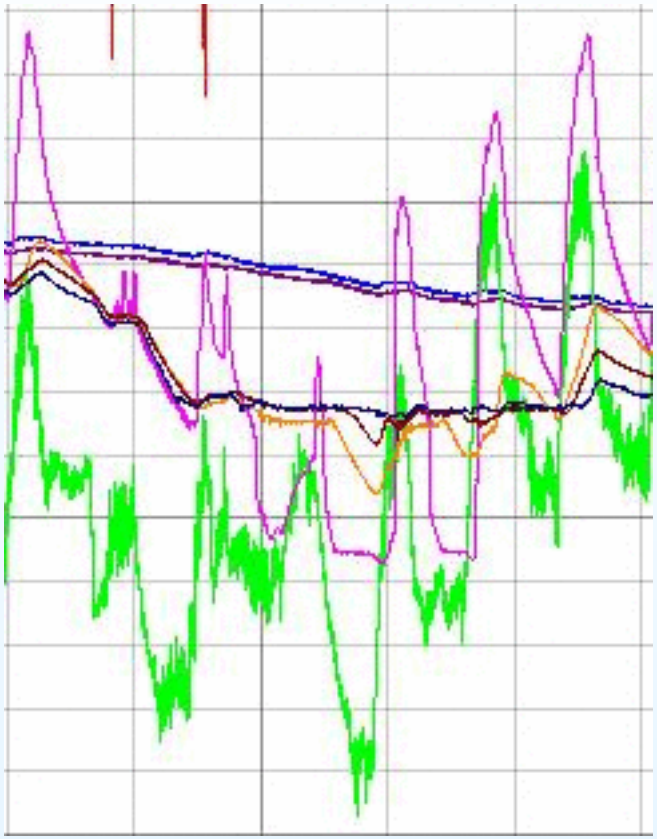
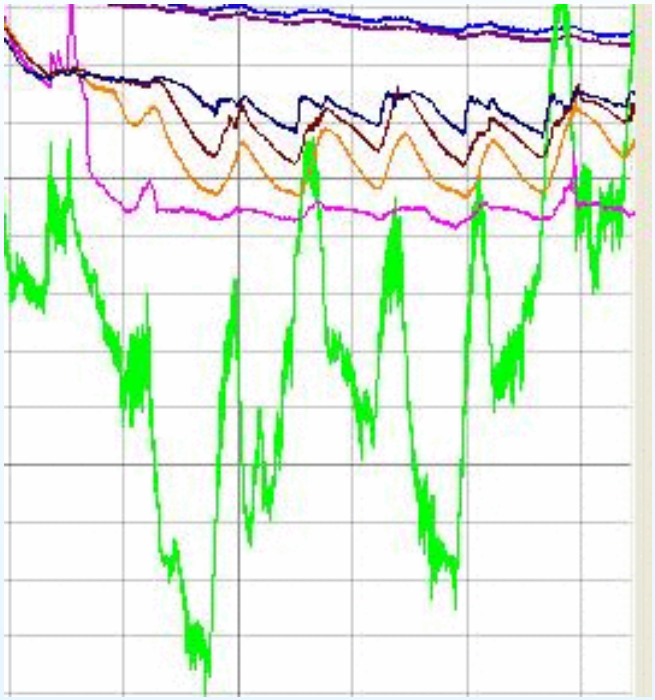
Tank temperature(s): **November 2006 details**

- **[left plot]** tank T-sensors show **inverted** T-gradient: coolest (top) to warmest (bottom) ... with top probably freezing at night and thawing during the day ... **not a good thing!**
- **[right plot]** now the top (**violet**) stays frozen day and night!

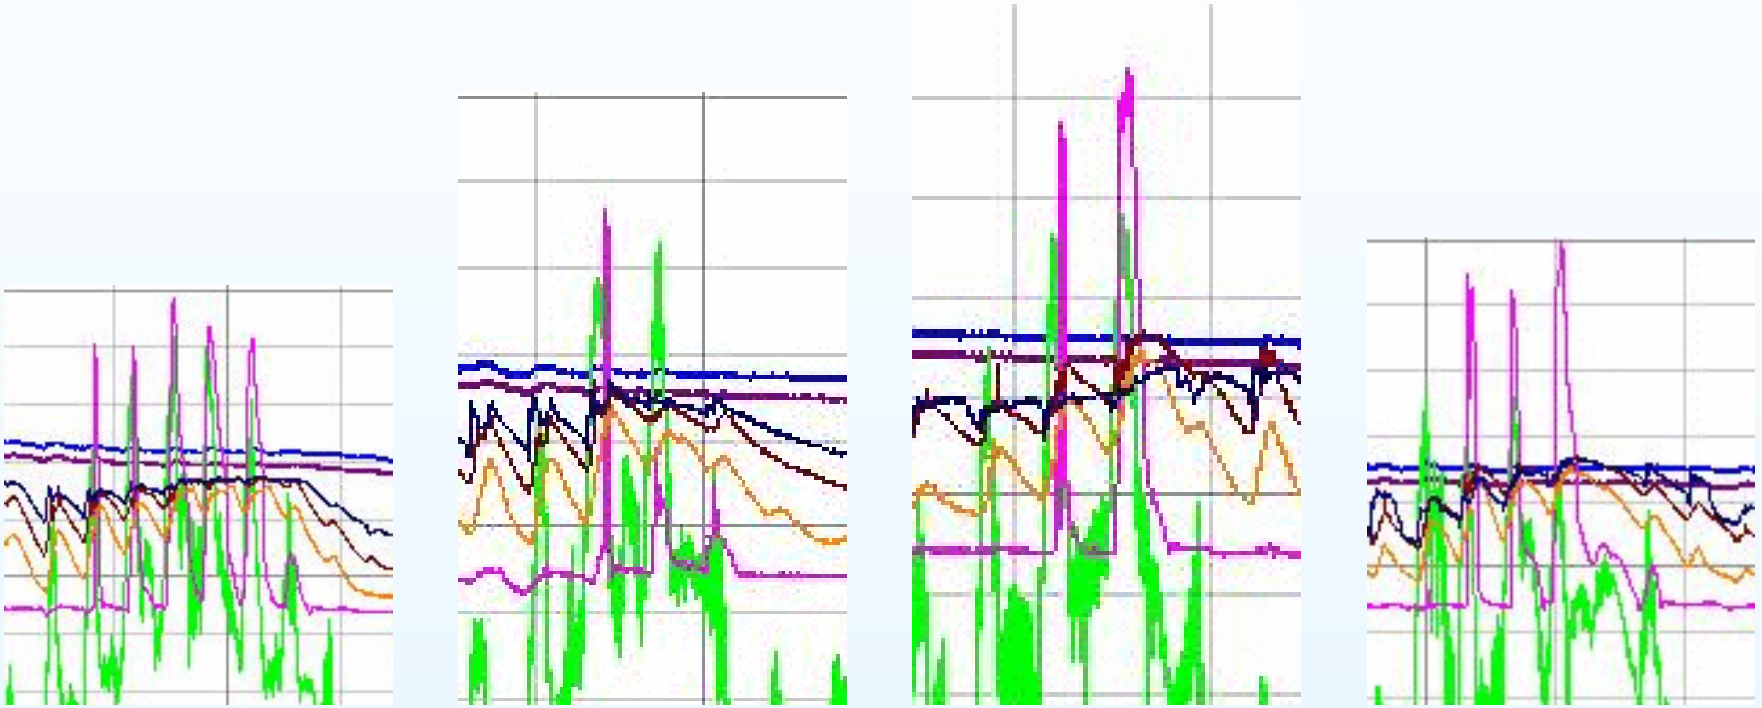
Next data access: **late January 2007 (III)**

- **Note:** likely temperature offset of $\sim 1^{\circ}$ for all sensors
- Many (**more**) examples of tank surface (**violet**) night-time freezing followed by day-time warming
- Other depths in the tank (**orange, brown and black**) above freezing

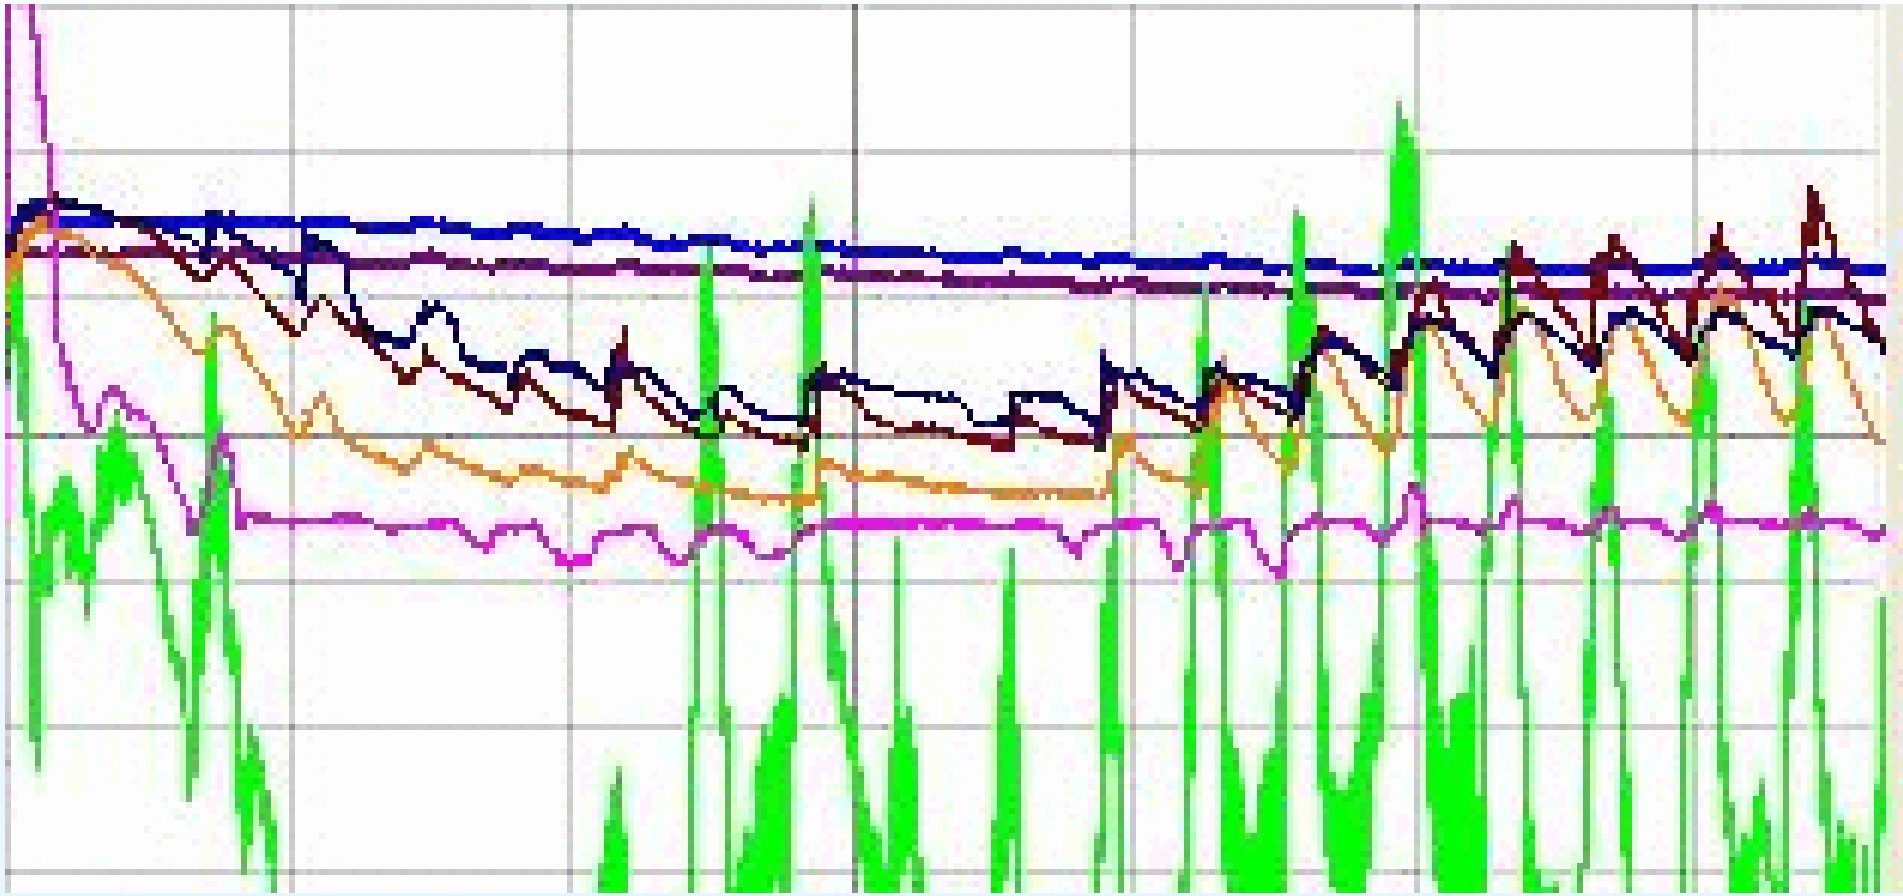
Next data access: **late January 2007 (IV)**

- Only **one** period of sustained freezing of the tank surface (**violet**)
- Middle of the tank (**orange**) close to 0° but probably above freezing
- **Ground temperatures remain above freezing** ($\sim 3^\circ$C)
